Methamphetamine FC Screening Assessment Report

Address inspected: 1/18 Sheehan Avenue Papakura, Auckland

Test type: Field Composite (FC) Swab Screening Test - no. of sample kits = ONE				
Conclusion: Screening result was negative for methamphetamine, indicating that no further testing is necessary. PROPERTY ALL CLEAR - NO METH DETECTED.				
Property description: 3 bedroom residential house.				
Sample Kit 1	Location	Photo	Result	
1 House	All rooms sampled.	Yes	NEGATIVEµg Field Composite Screening tests combine the level of the rooms tested.	
2				
3	See pics for exact locations.			
4	Total locations swabbed = 11	Yes

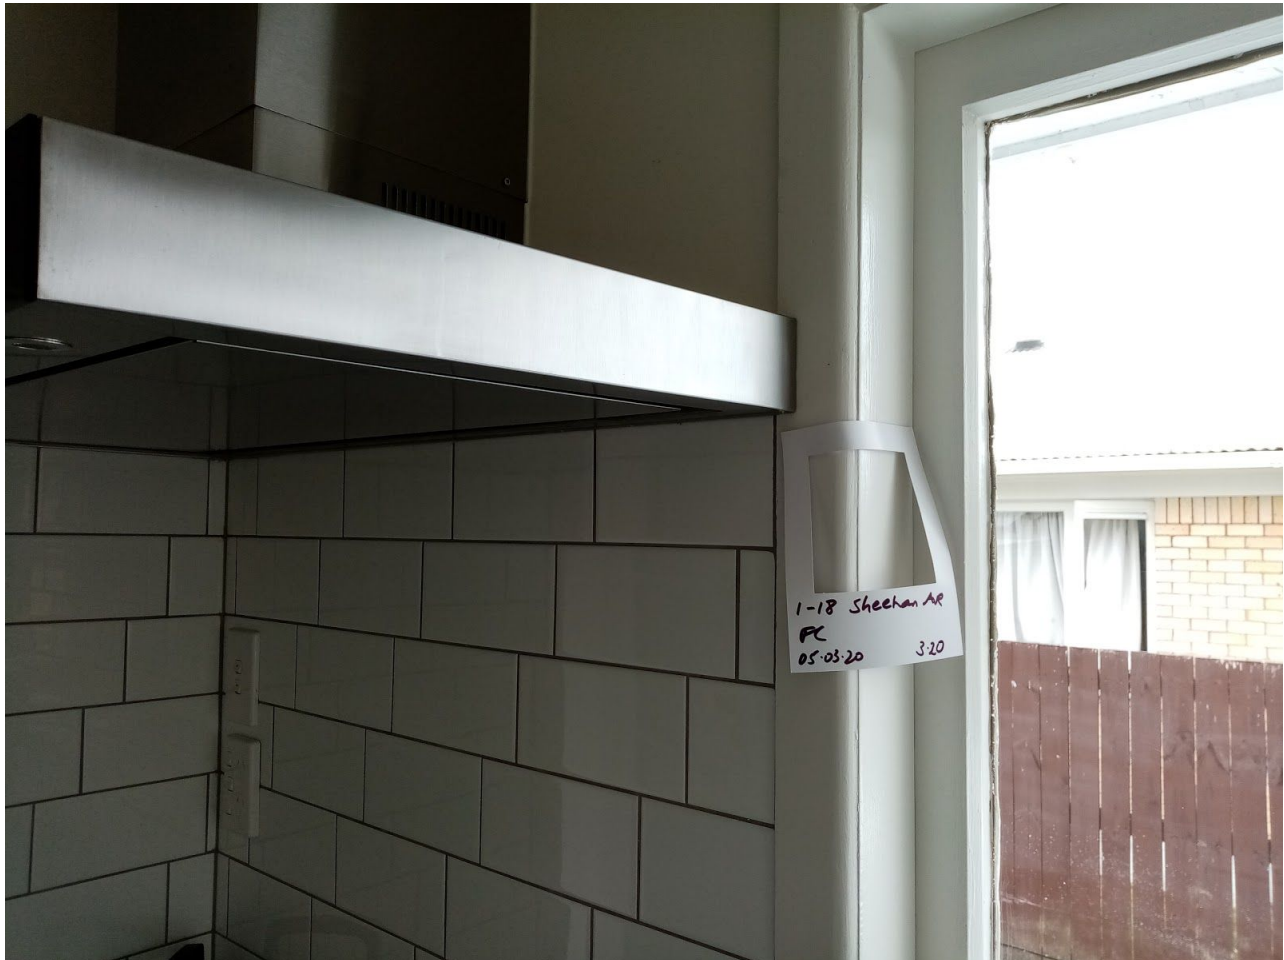
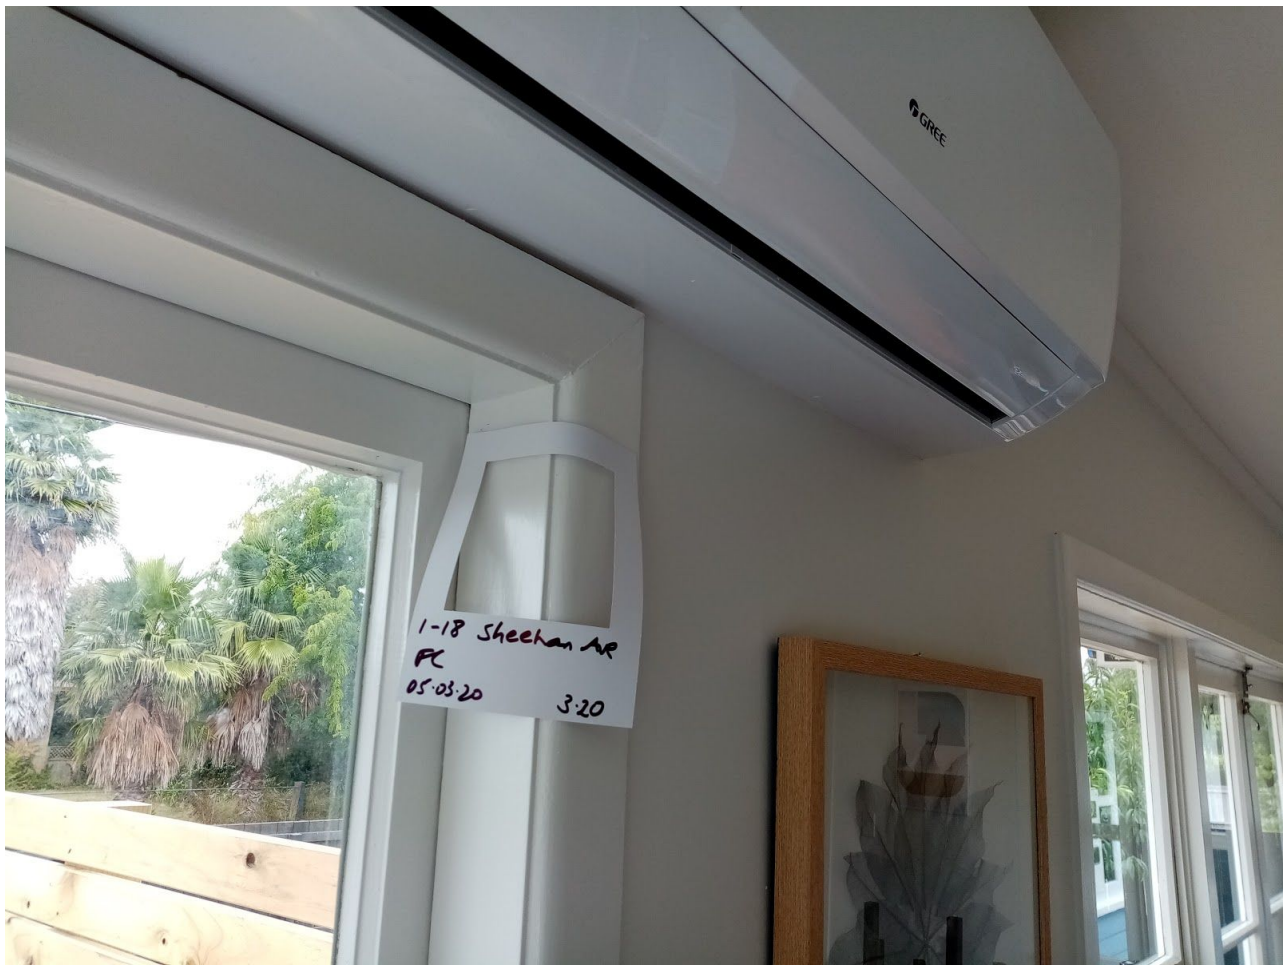
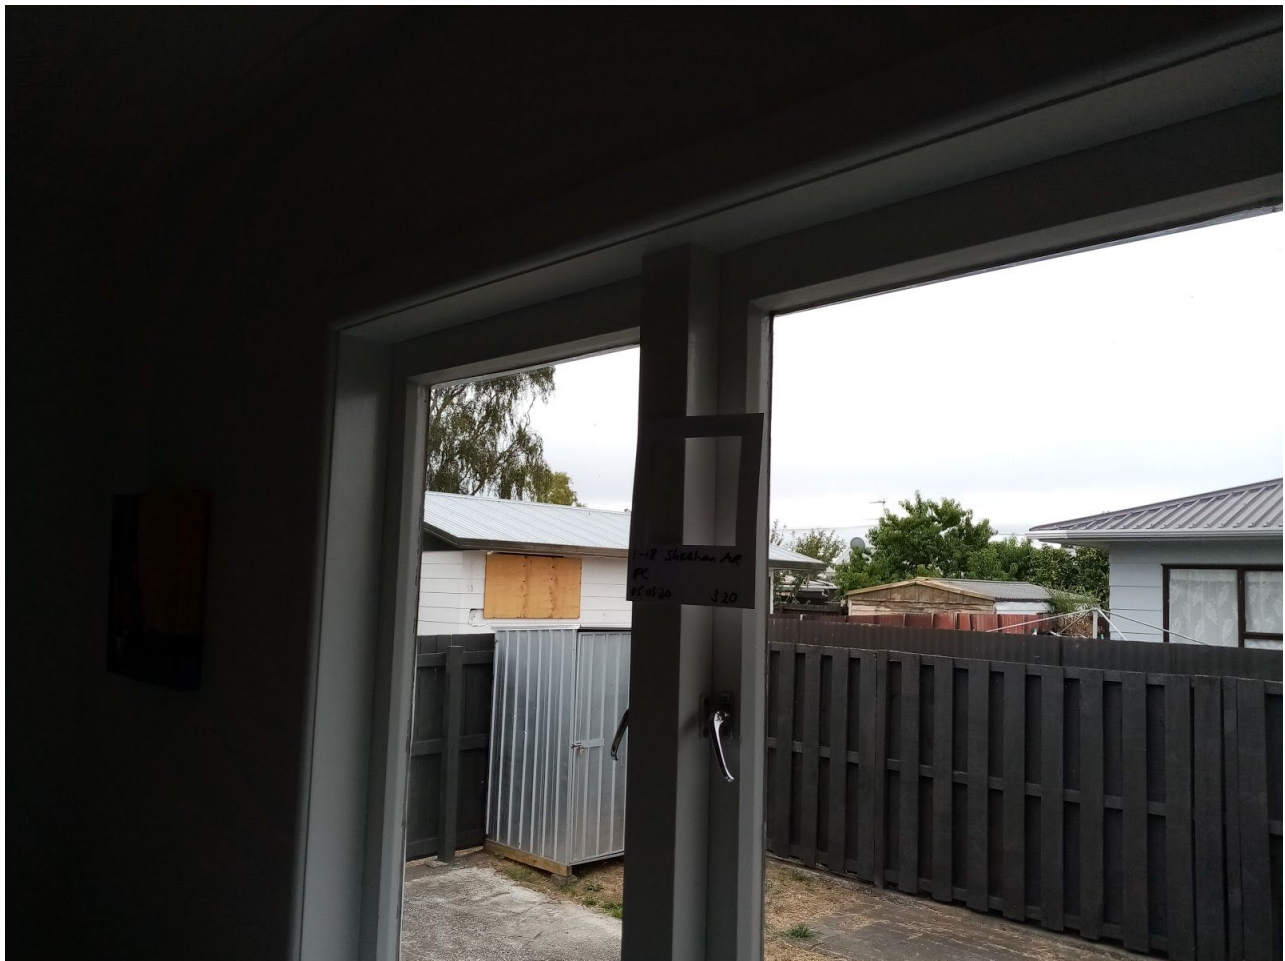
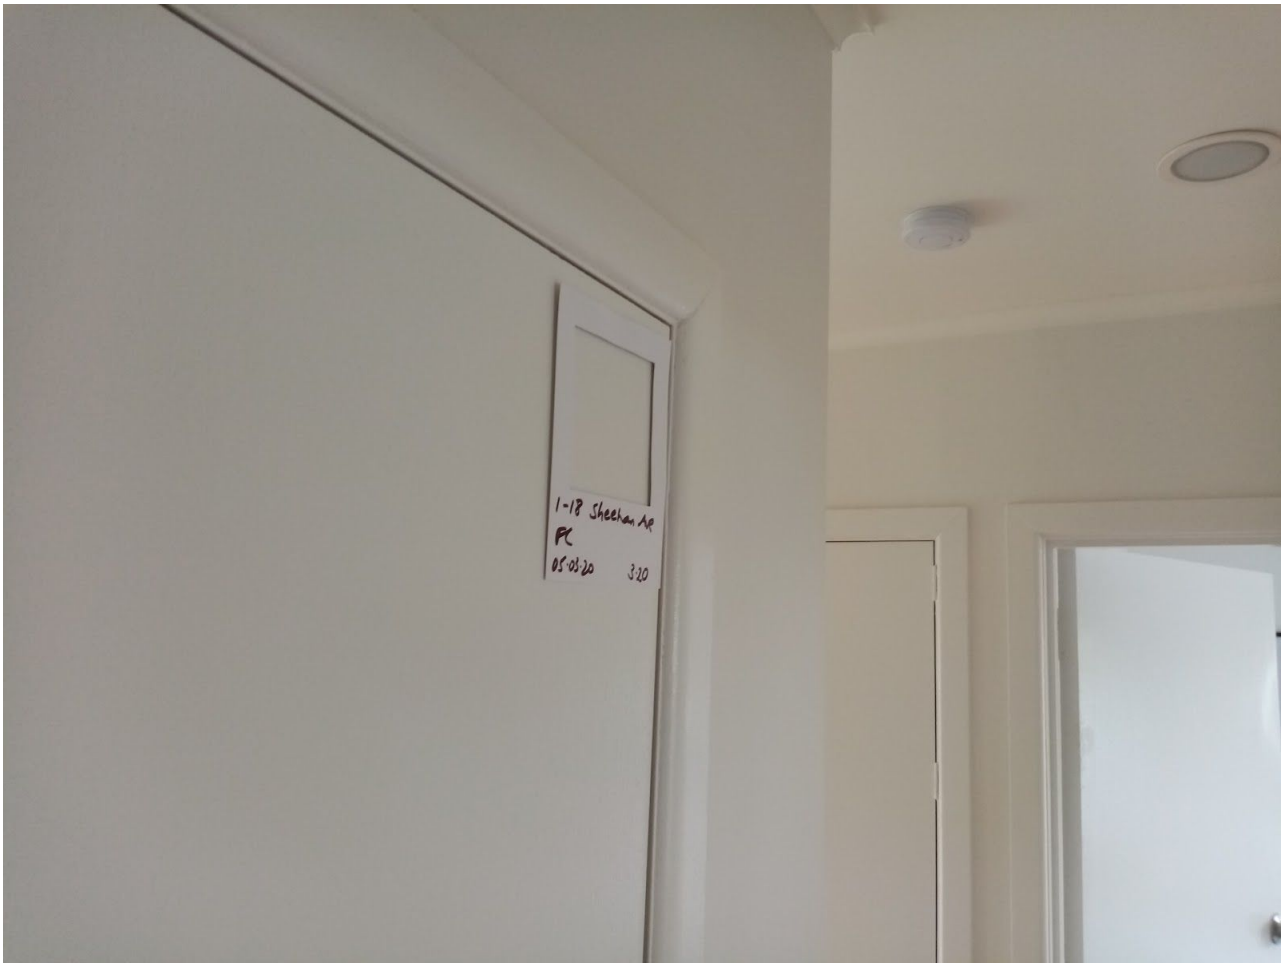
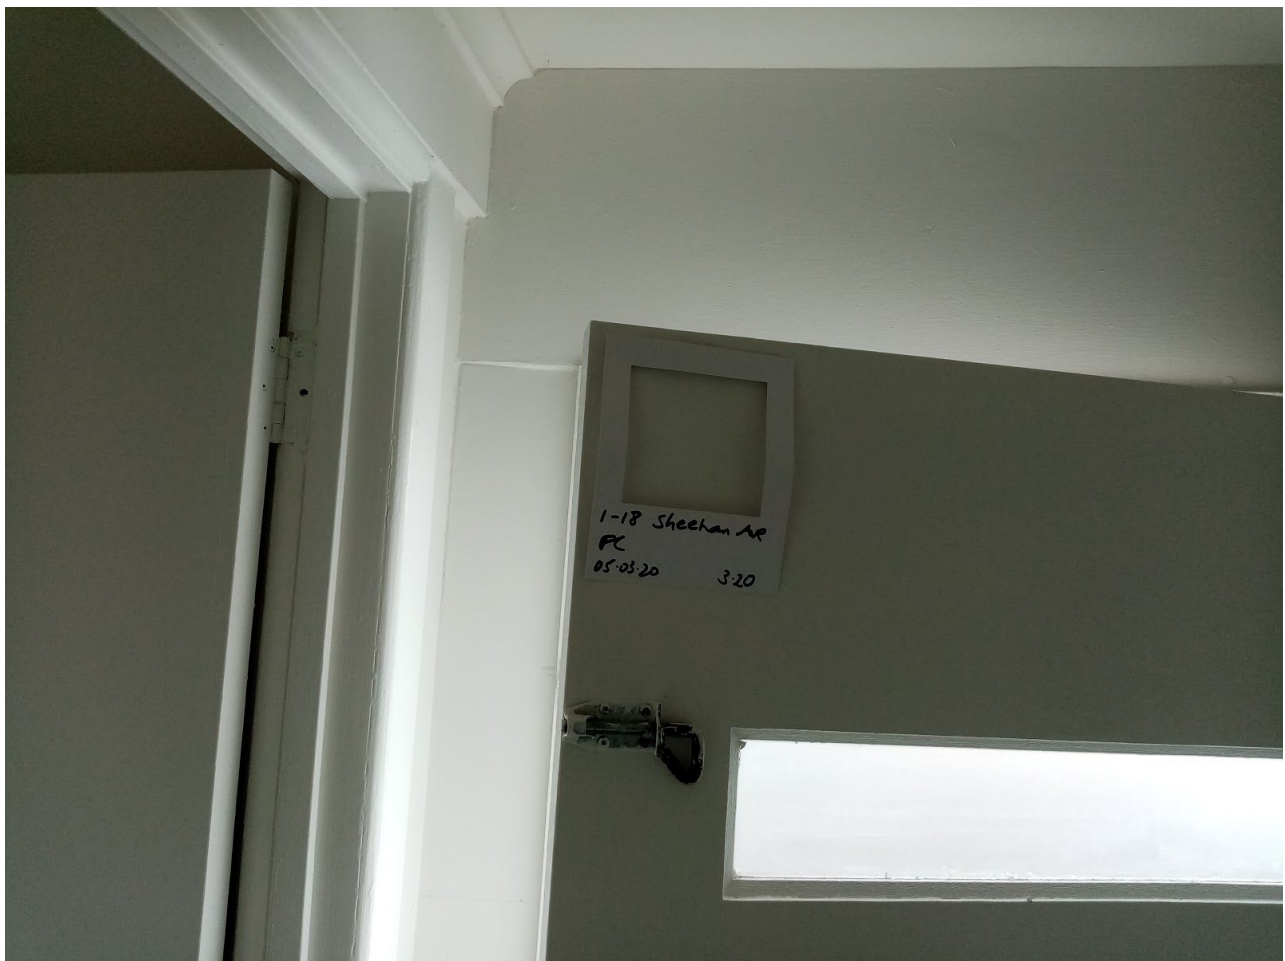
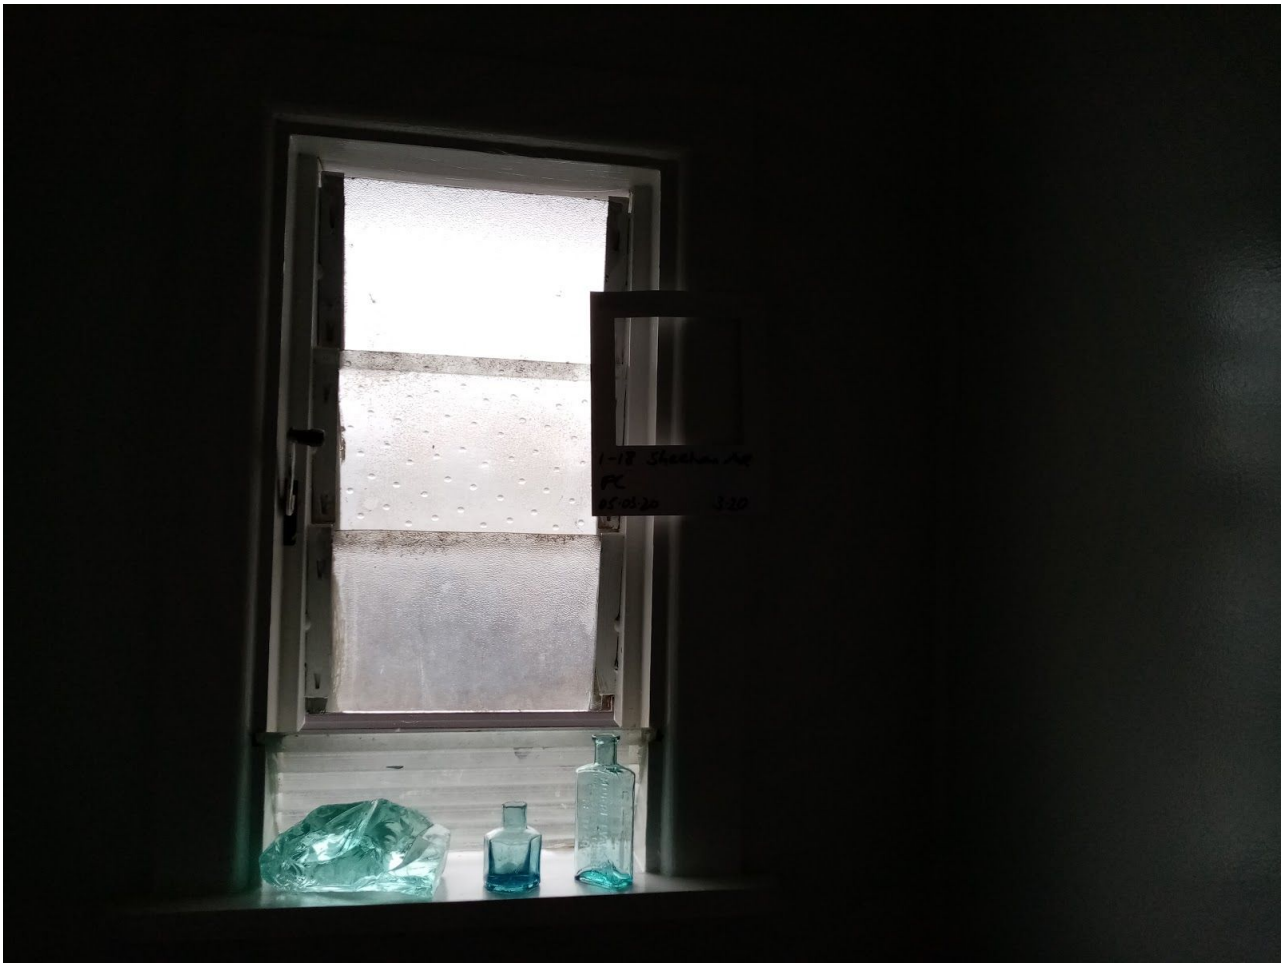
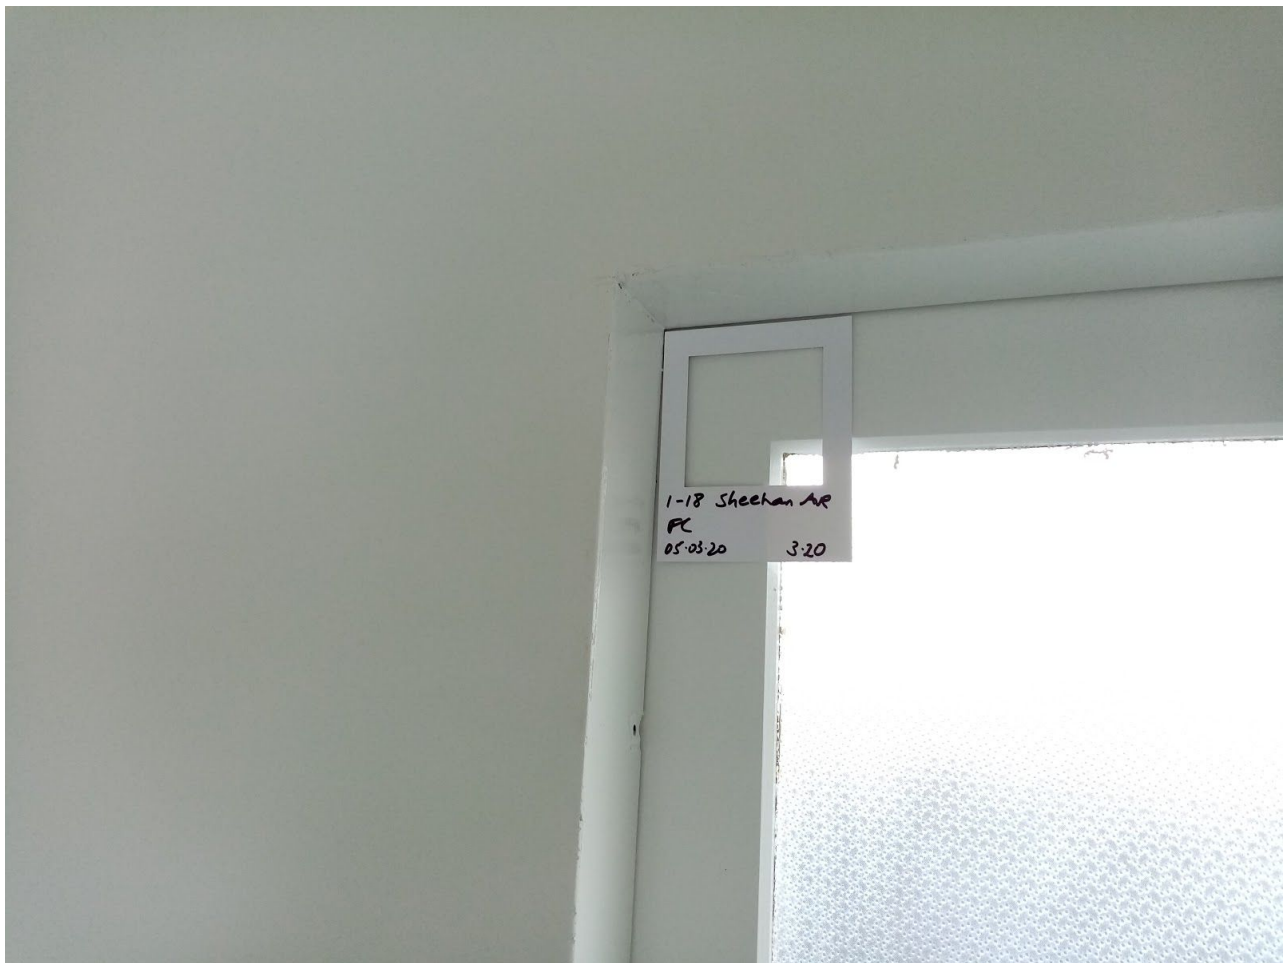
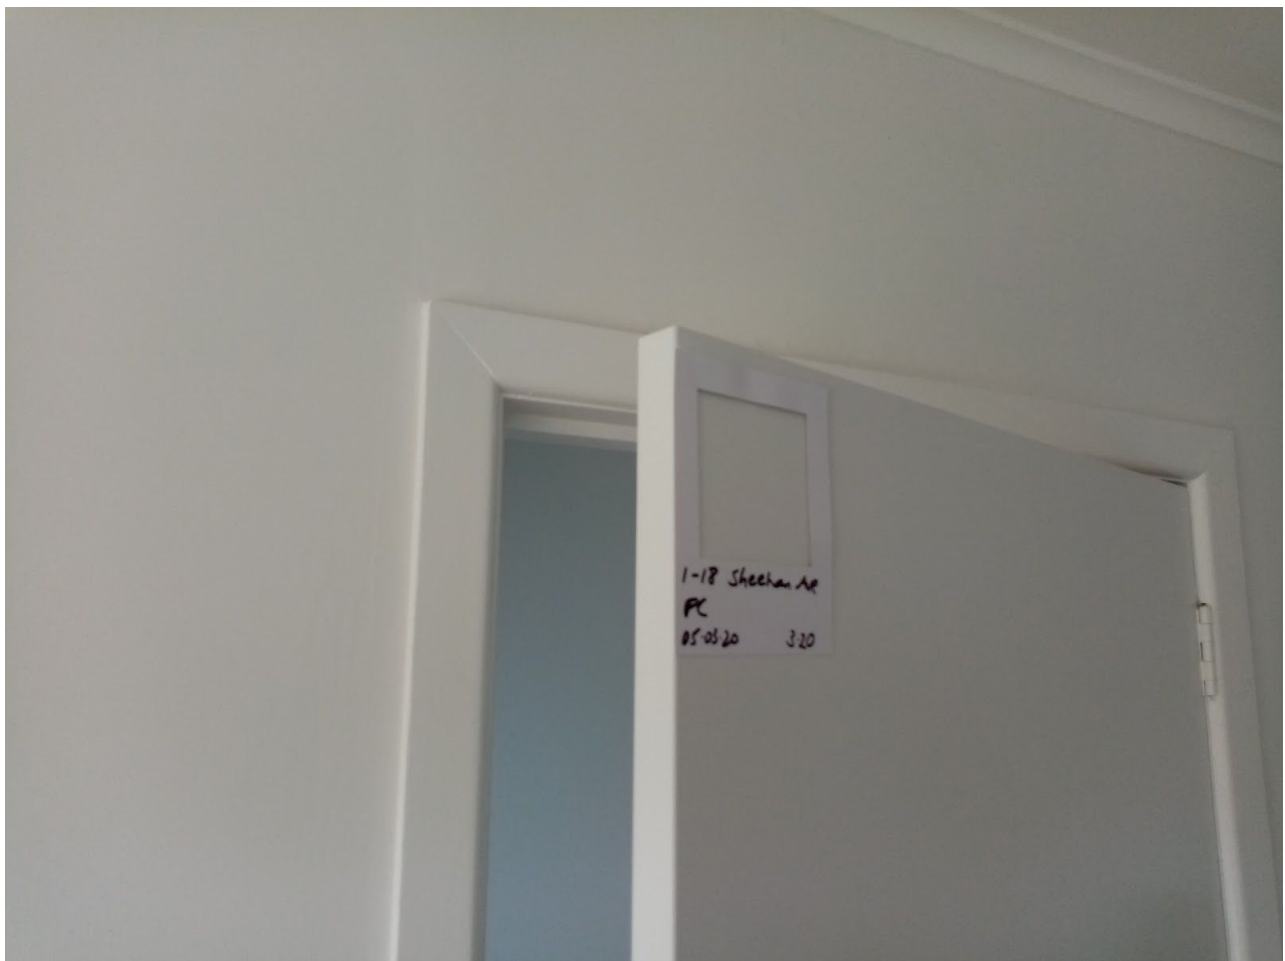
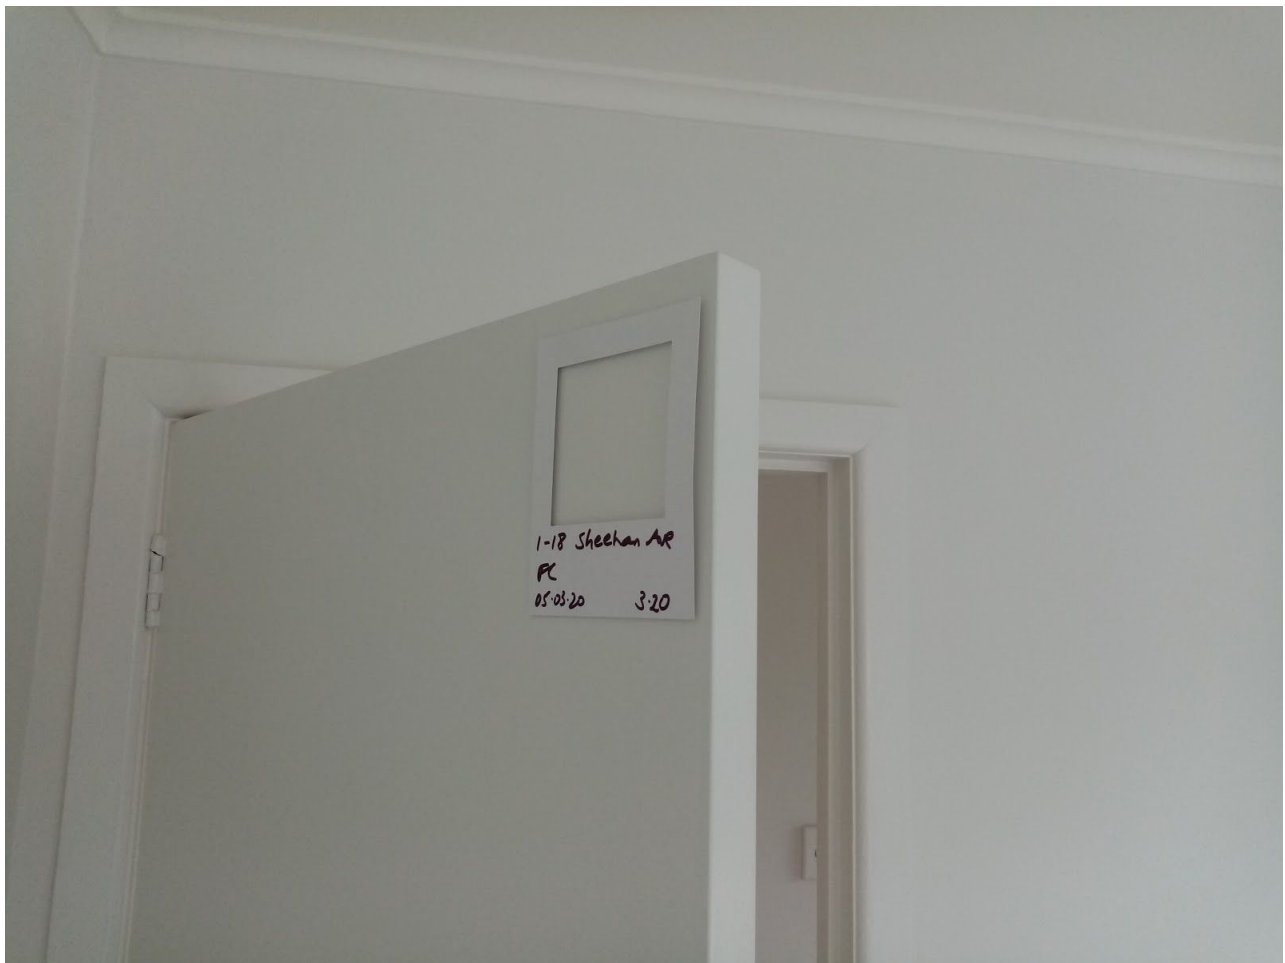
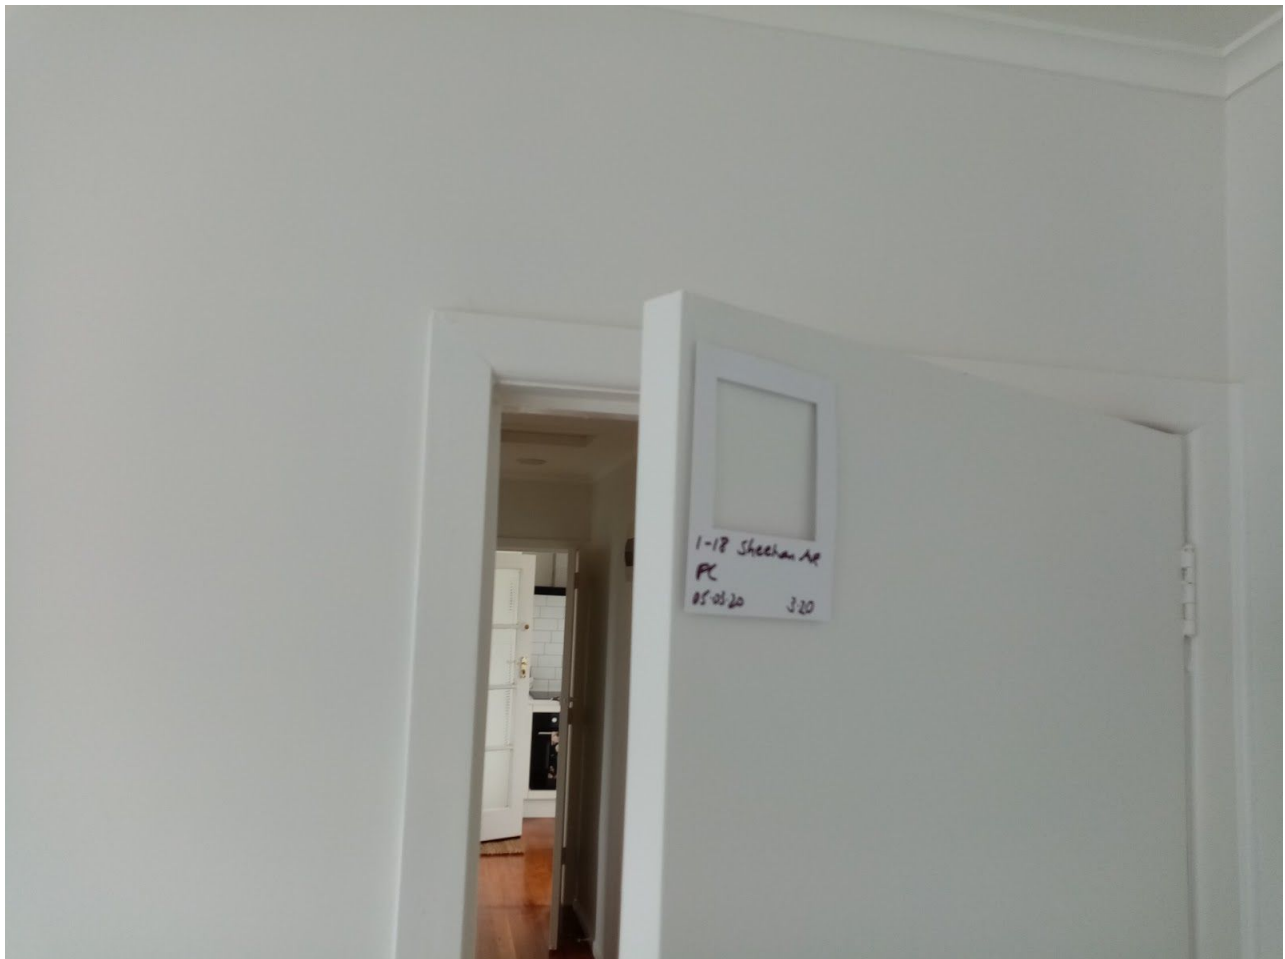
Pictures are for reference if further testing or other evaluation needed.

Photos and samples usually taken in a clockwise direction around house, starting in kitchen.
